WINNIPAUKE DAM
(A/K/A/ FLOCK PROCESS DAM)
CT 00531

NORWALK RIVER BASIN
NORWALK, CONNECTICUT

PHASE I INSPECTION REPORT
NATIONAL DAM INSPECTION PROGRAM

Re: Winnipauk Dam (a/k/a Flock Process Dam)
Norwalk, Connecticut

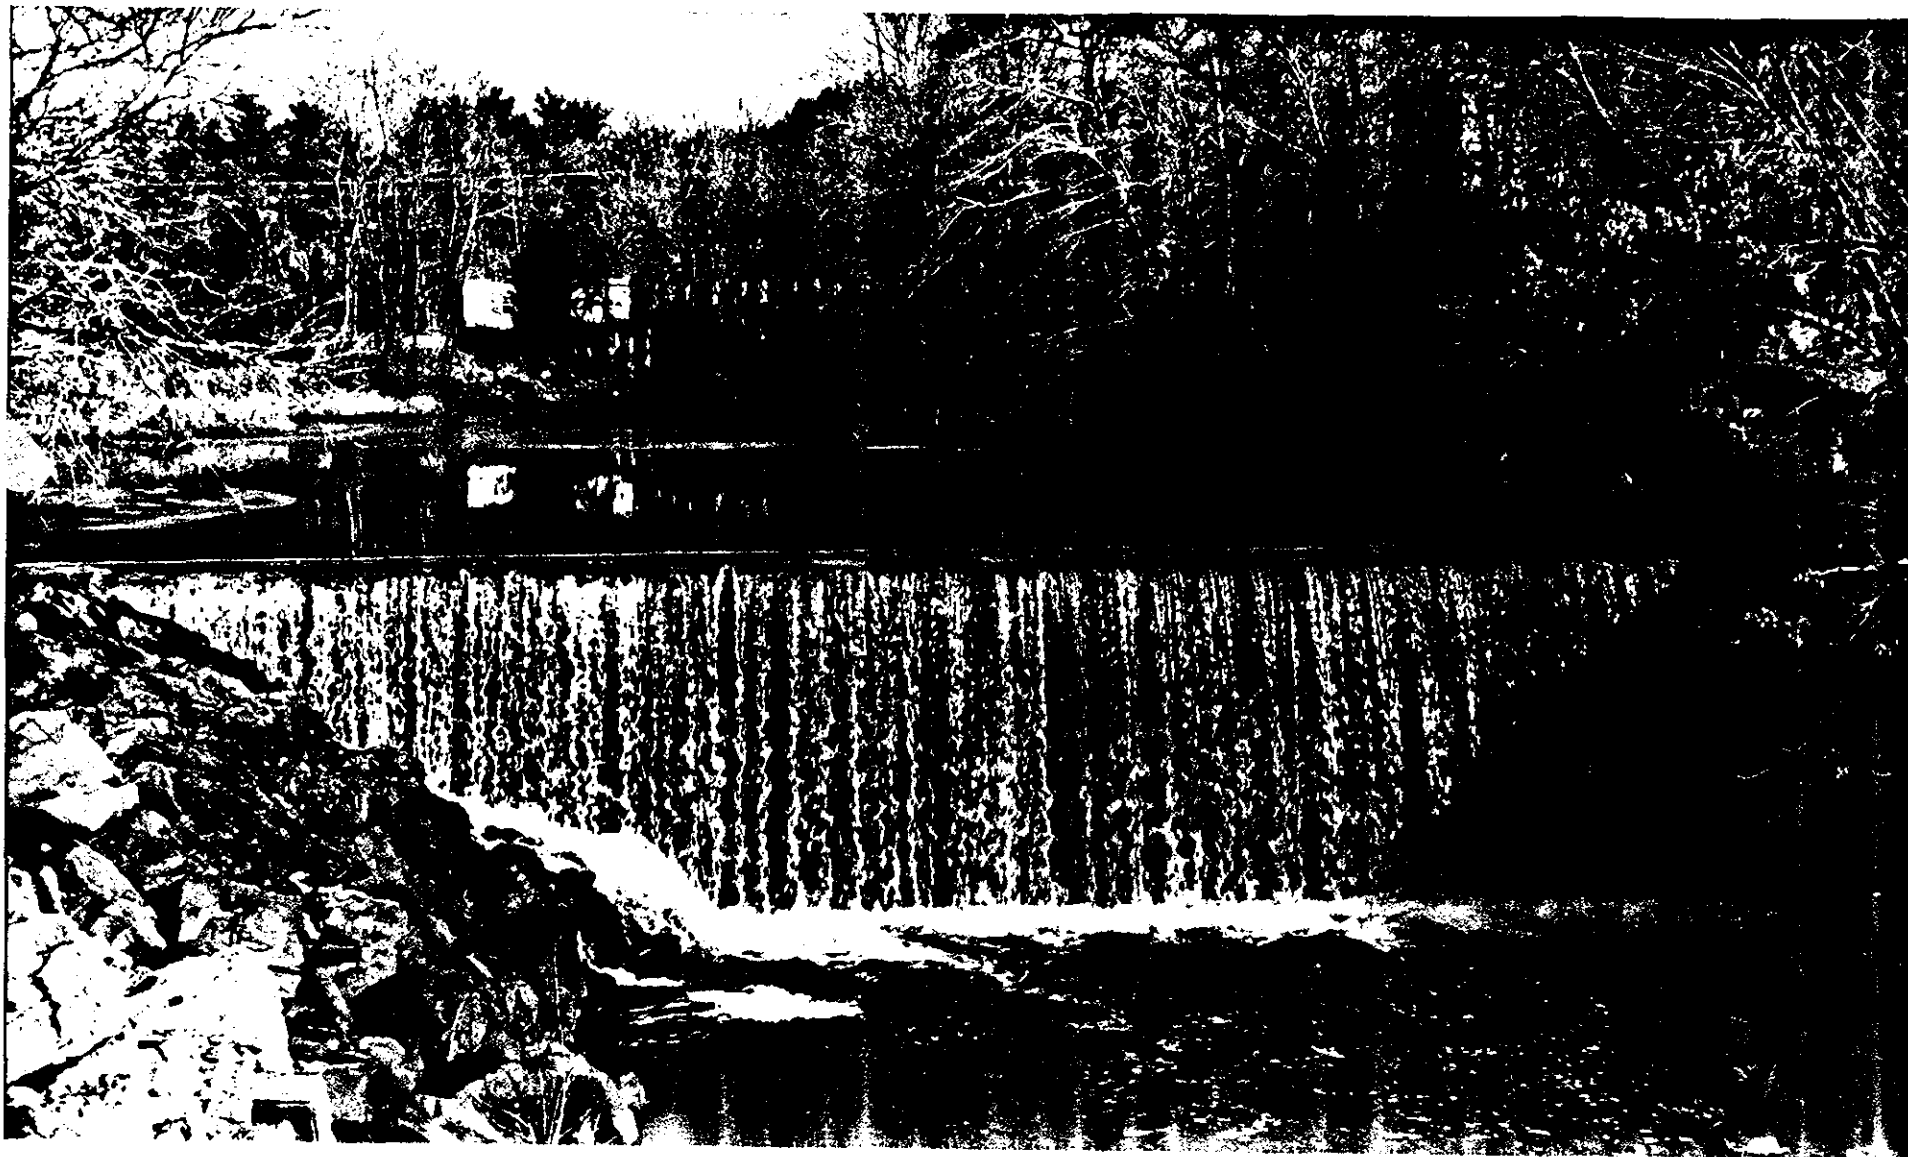
OVERVIEW PHOTO

The Winnipauk Dam is a run-of-the-river dam consisting of a stone masonry wall with a concrete cap and an upstream earth embankment. The dam has an overflow crest length of 75 feet, a maximum height of 22 feet and outlet works at the left abutment, Overview Photo and Photo 1. The right abutment is a ledge outcrop, Photo 2. A railroad line runs along the right abutment, Photo 1.

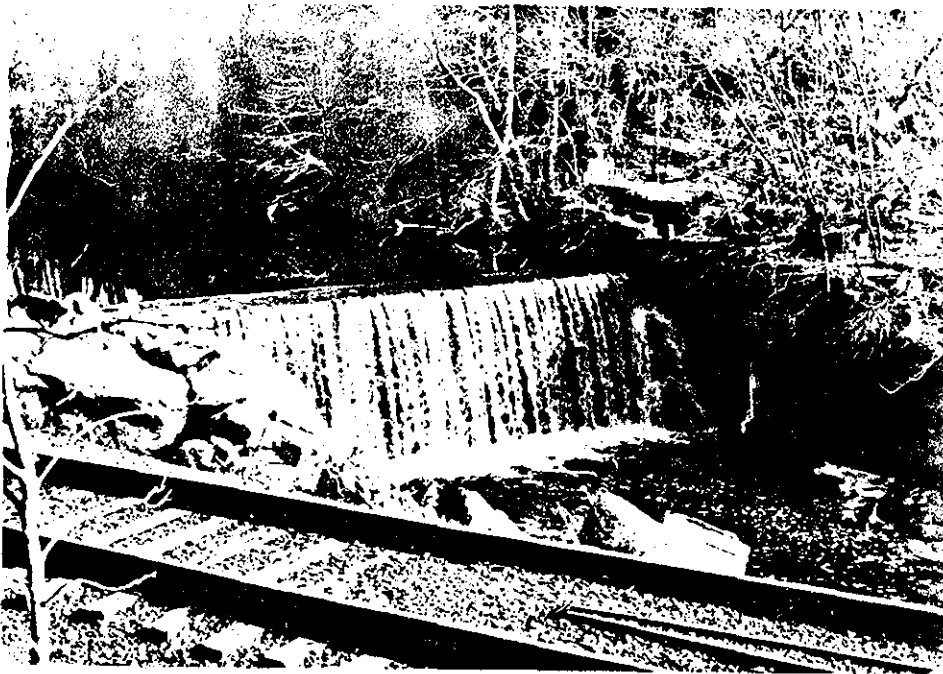
PHOTO NO. 1

There was 0.3 feet of water going over the spillway at the time of inspection, so the condition of the stone masonry wall could not be observed. The concrete weir appeared to be in fair condition. The weir had what looked to be wood planking on both the upstream and downstream edges.

SPILLWAY

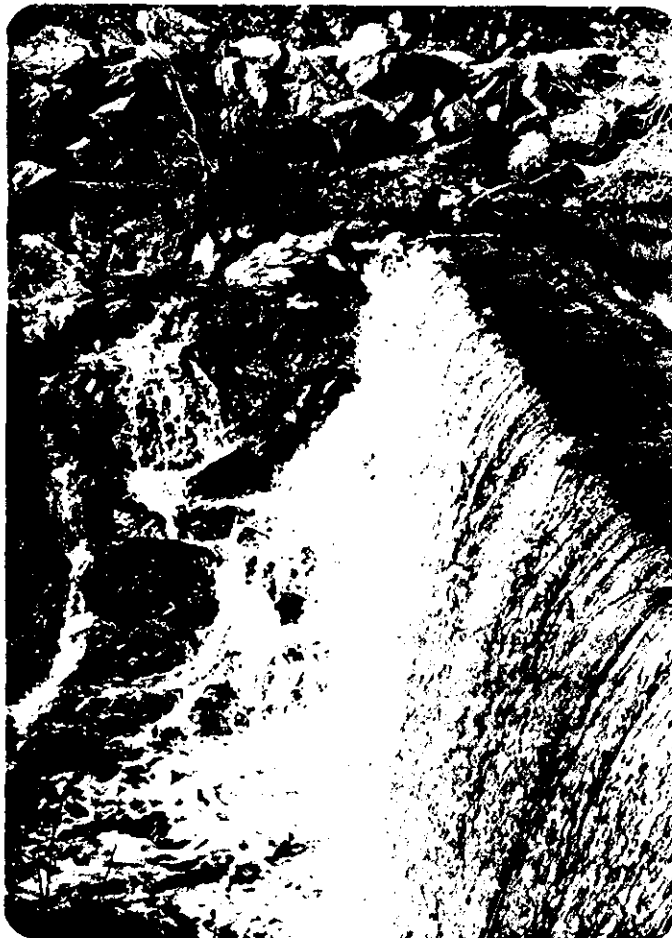
PHOTO NO. 2

EXPOSED LEDGE AT
RIGHT ABUTMENT

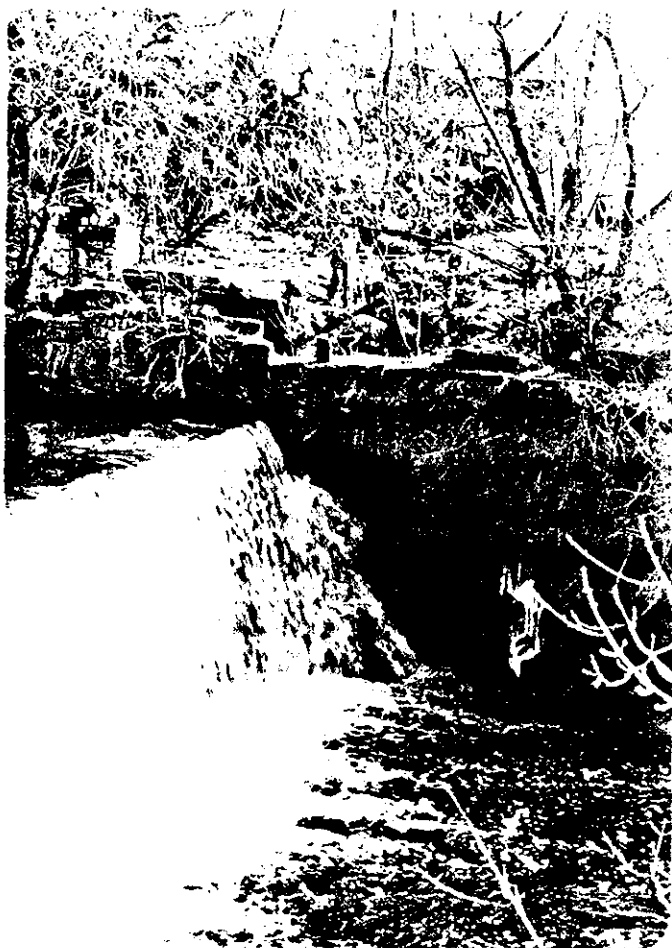
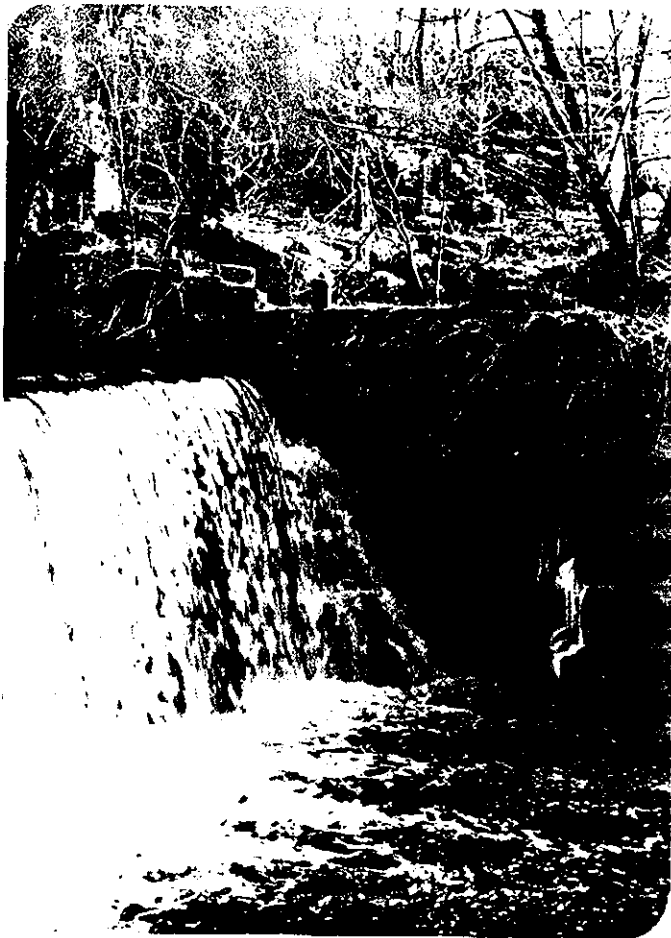
PHOTO NO. 3

The outlet works at the left abutment, Photo 3, consist of a stone masonry and concrete structure with a 5-1/2' by 5-1/2' sluice gate on the upstream side, Photo 4, which discharges through a partially collapsed 6 foot wide by 4 foot high stone archway at the toe of the left abutment, Photo 3. The sluice gate is obstructed with leaves, sticks and debris and appears to be inoperable. The concrete top of the outlet structure is partially collapsed and the chamber is filled with debris.

LEFT ABUTMENT
AND OUTLET WORKS

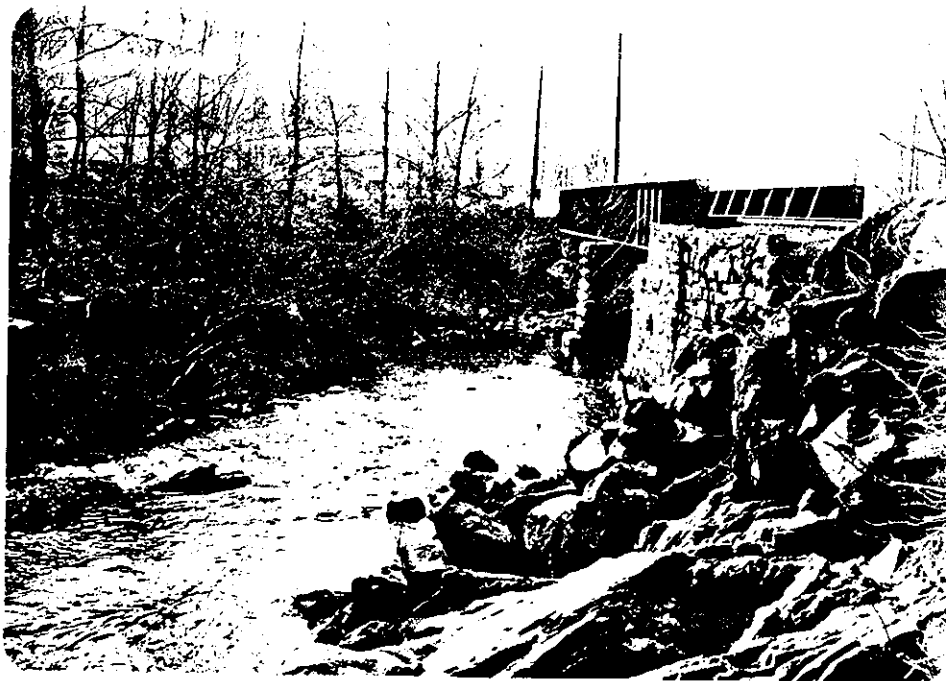
PHOTO NO. 5

The downstream channel is the natural river channel, mostly in ledge. A railroad bridge crosses the river approximately 200 feet downstream of the dam, Photo 5. Downstream of the railroad bridge a Corps of Engineers' channel improvement project has provided a channel capacity of about 17,000 cubic feet per second (cfs).

RAILROAD BRIDGE LOOKING DOWNSTREAM FROM DAM.

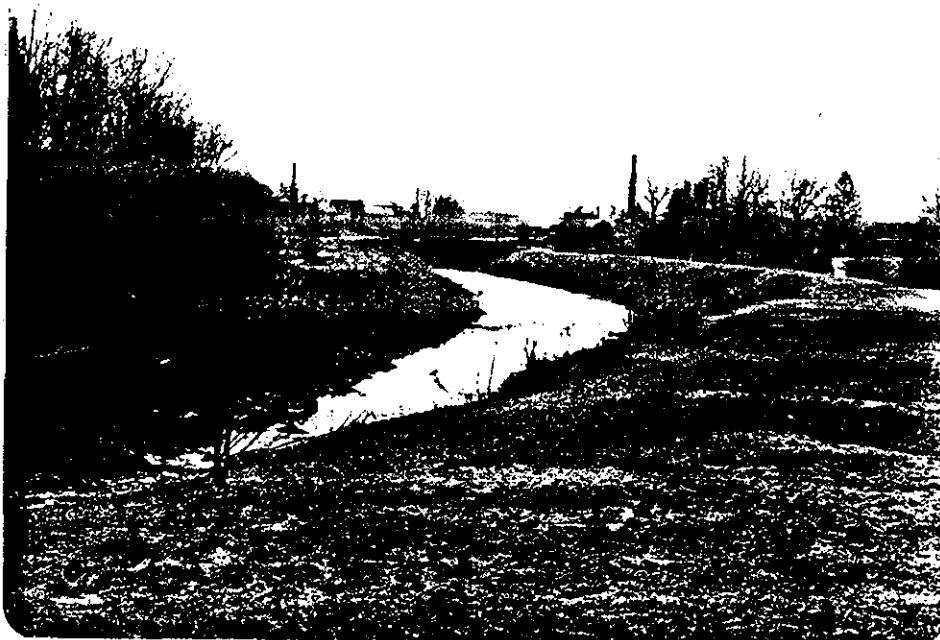
PHOTO NO. 6

RIVER CHANNEL LOOKING DOWNSTREAM
FROM RAILROAD BRIDGE.

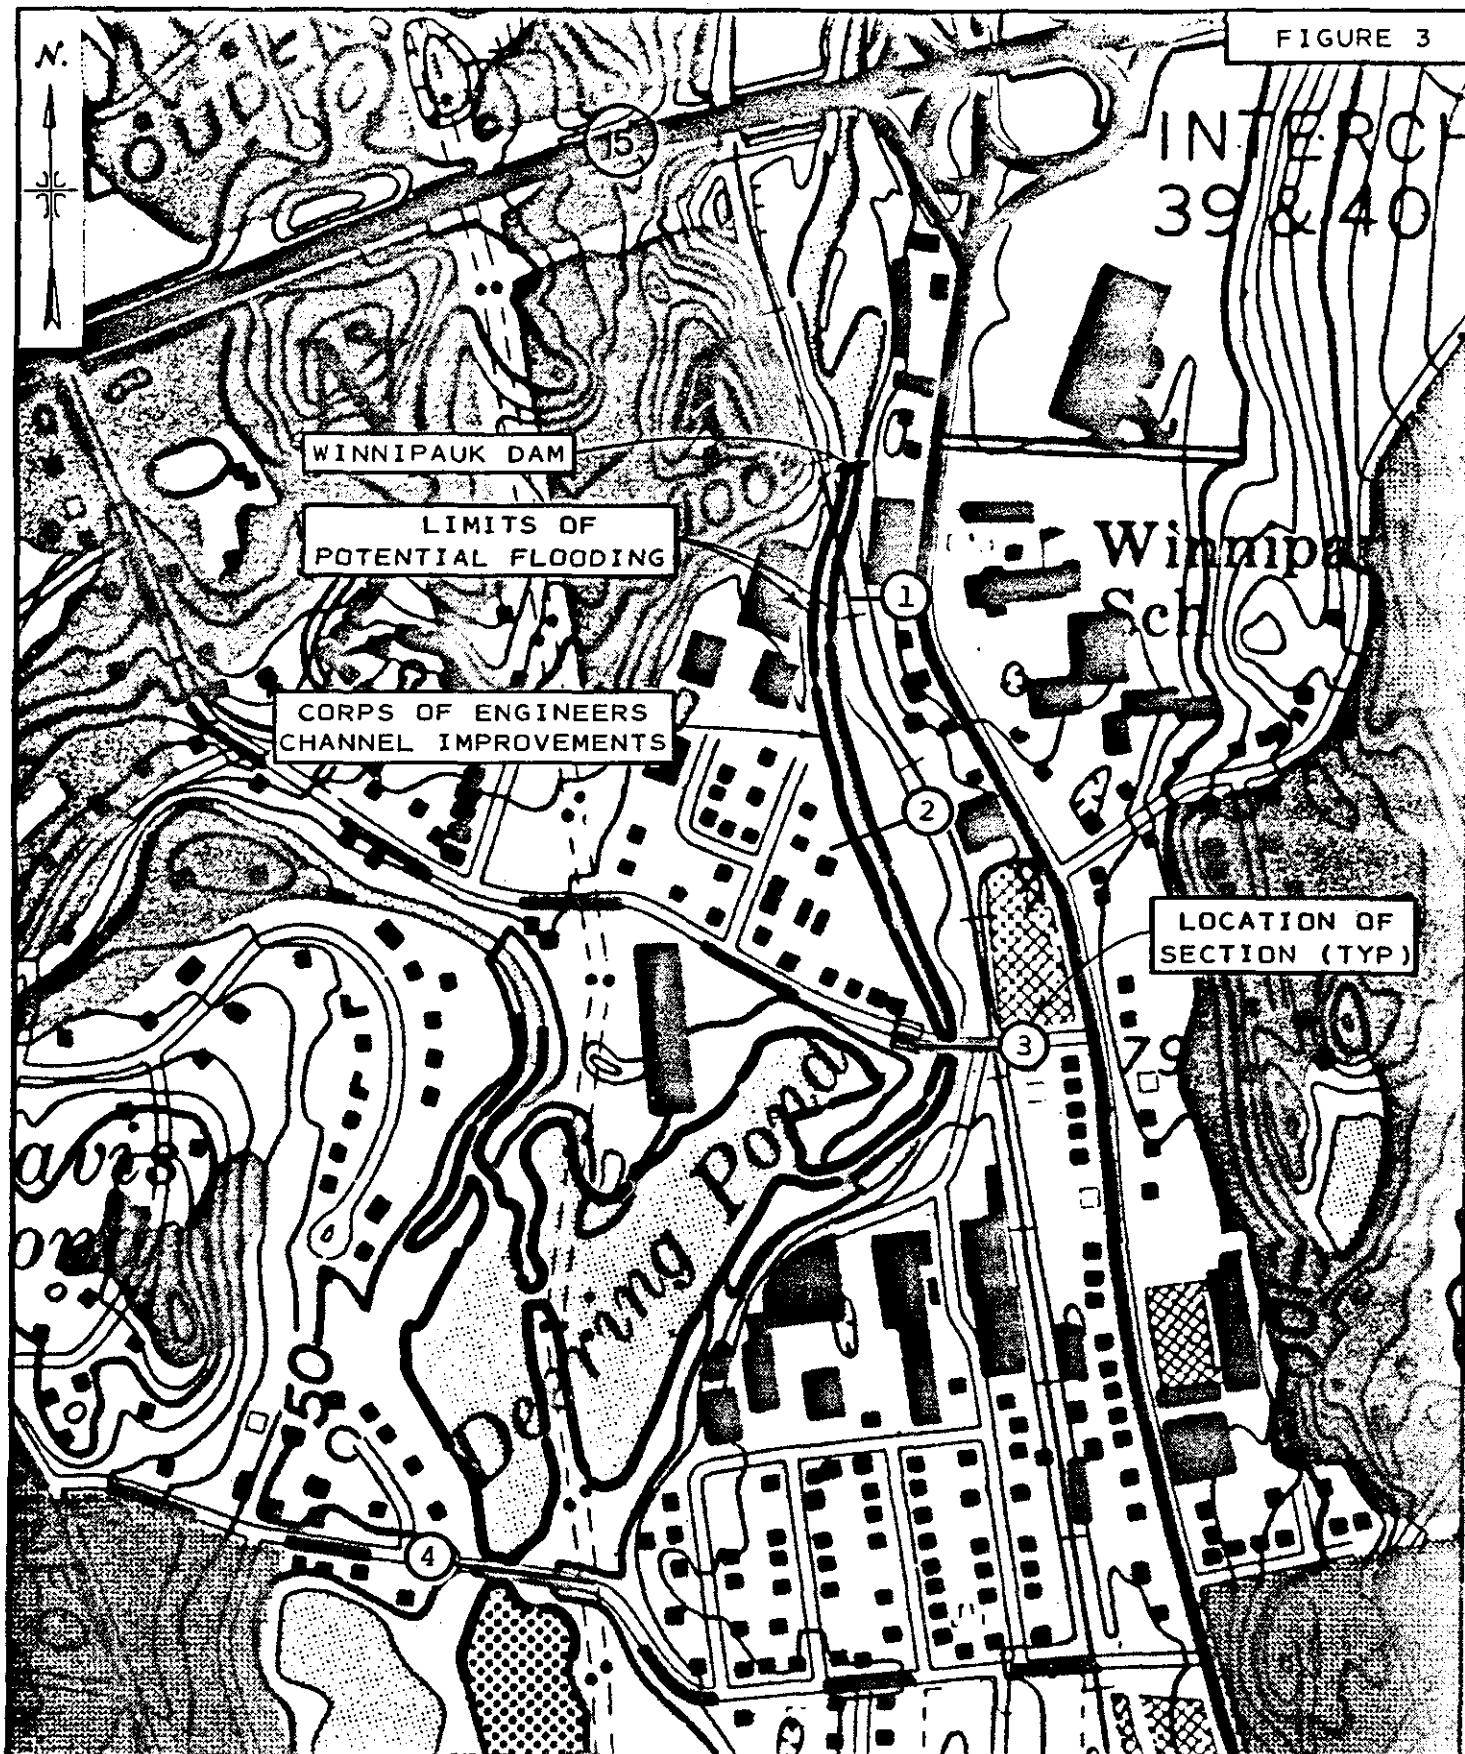
FIGURE 3

The peak flood flow for a failure with the water level at the top of the dam would be 7,700 cfs, and failure at spillway level would be 3,000 cfs. Neither flow would exceed the capacity of the downstream channel.

The flood routing shows the dam to be "Low" potential hazard.

LIMITS OF POTENTIAL FLOODING
WINNIPAUK DAM

FAILURE WITH WATER LEVEL AT TOP OF DAM
